## MSHA's Accident Prevention Program Safety Idea

### "Safe Access: Beware of Appearances"

Category : Maintenance

Mine Type: All Surface

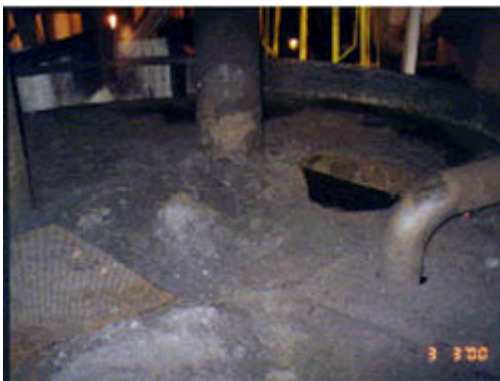
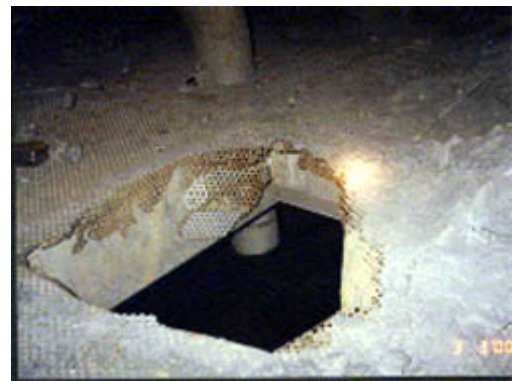
While running conduit in a preparation plant, an electrician fell into an operating cyclone sump while working from a perforated plate screen that covered the top of the sump. The fatal accident occurred when a section of the screen gave way under the weight of the worker.

The purpose of the screen was to keep extraneous material from getting into the sump. The screen was not designed or intended to be walked upon and over time it had been weakened by corrosion. There was an access ladder to the top of the sump, but it was only intended to provide a vantage point for checking the pumps and pipes.

- 1) Where persons need to work above a sump or other open vessel, provide a safe means of access.
- 2) Beware of situations where a worker may assume that it is safe to walk on a cover that is not intended or engineered to support their weight.
- 3) Where a cover on a sump or other open vessel is not designed or intended to support personnel, make sure that warning signs are provided and access blocked.
- 4) Where safe walkways are not available for performing maintenance activities, ensure that workers use appropriate fall protection.
- 5) Check with the vessel manufacturers on what options they can provide for safe access. Manufacturers can provide covers of corrosion-resistant material, such as stainless steel, designed to safely support the weight of personnel.
